La Clinica del Pueblo de Rio Arriba

Facility Assessment Study

Phase One

November 9, 2007

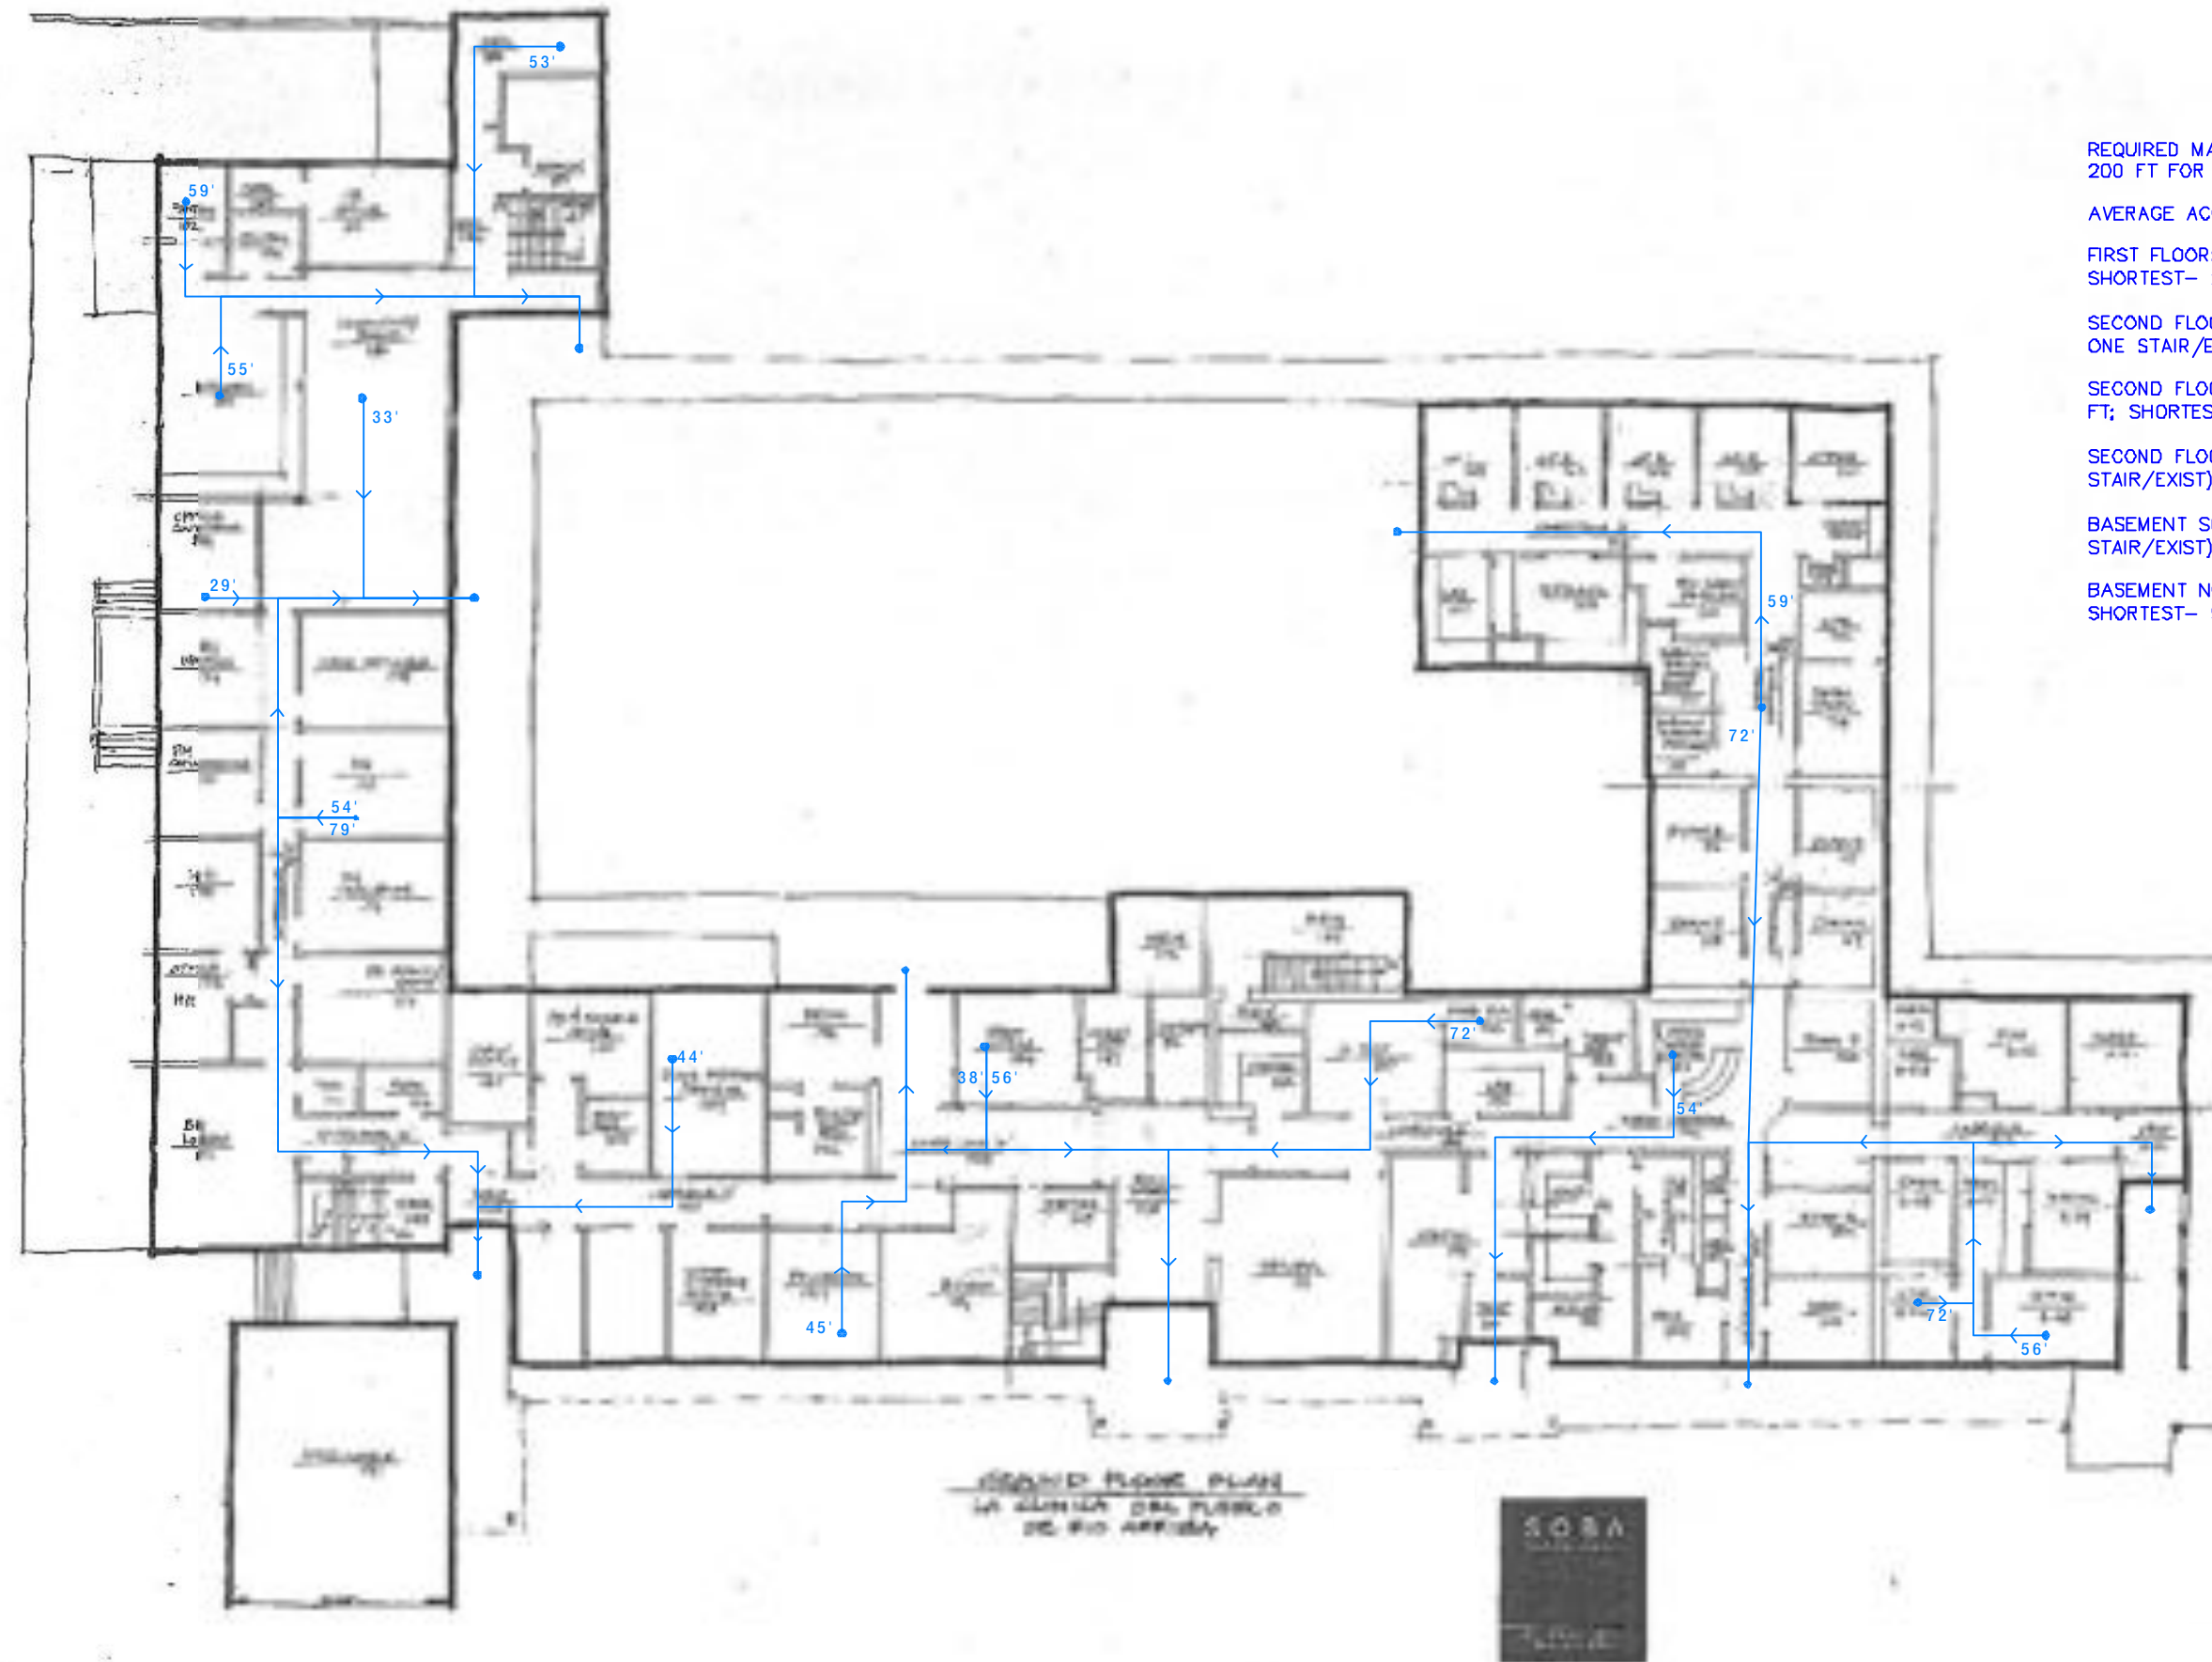
REQUIRED MAX ACCESS TRAVEL DISTANCE-
200 FT FOR NON-SPRINKLER BUILDING

AVERAGE ACCESS TRAVEL DISTANCE;

FIRST FLOOR: 54 FT; LONGEST- 79 FT;
SHORTEST- 29 FT (NINE EXITS)

BASEMENT SOUTH: 85 FT (ONLY ONE
STAIR/EXIST)

BASEMENT NORTH: 105 FT; LONGEST— 115 FT;
SHORTEST— 95 FT (TWO EXITS)

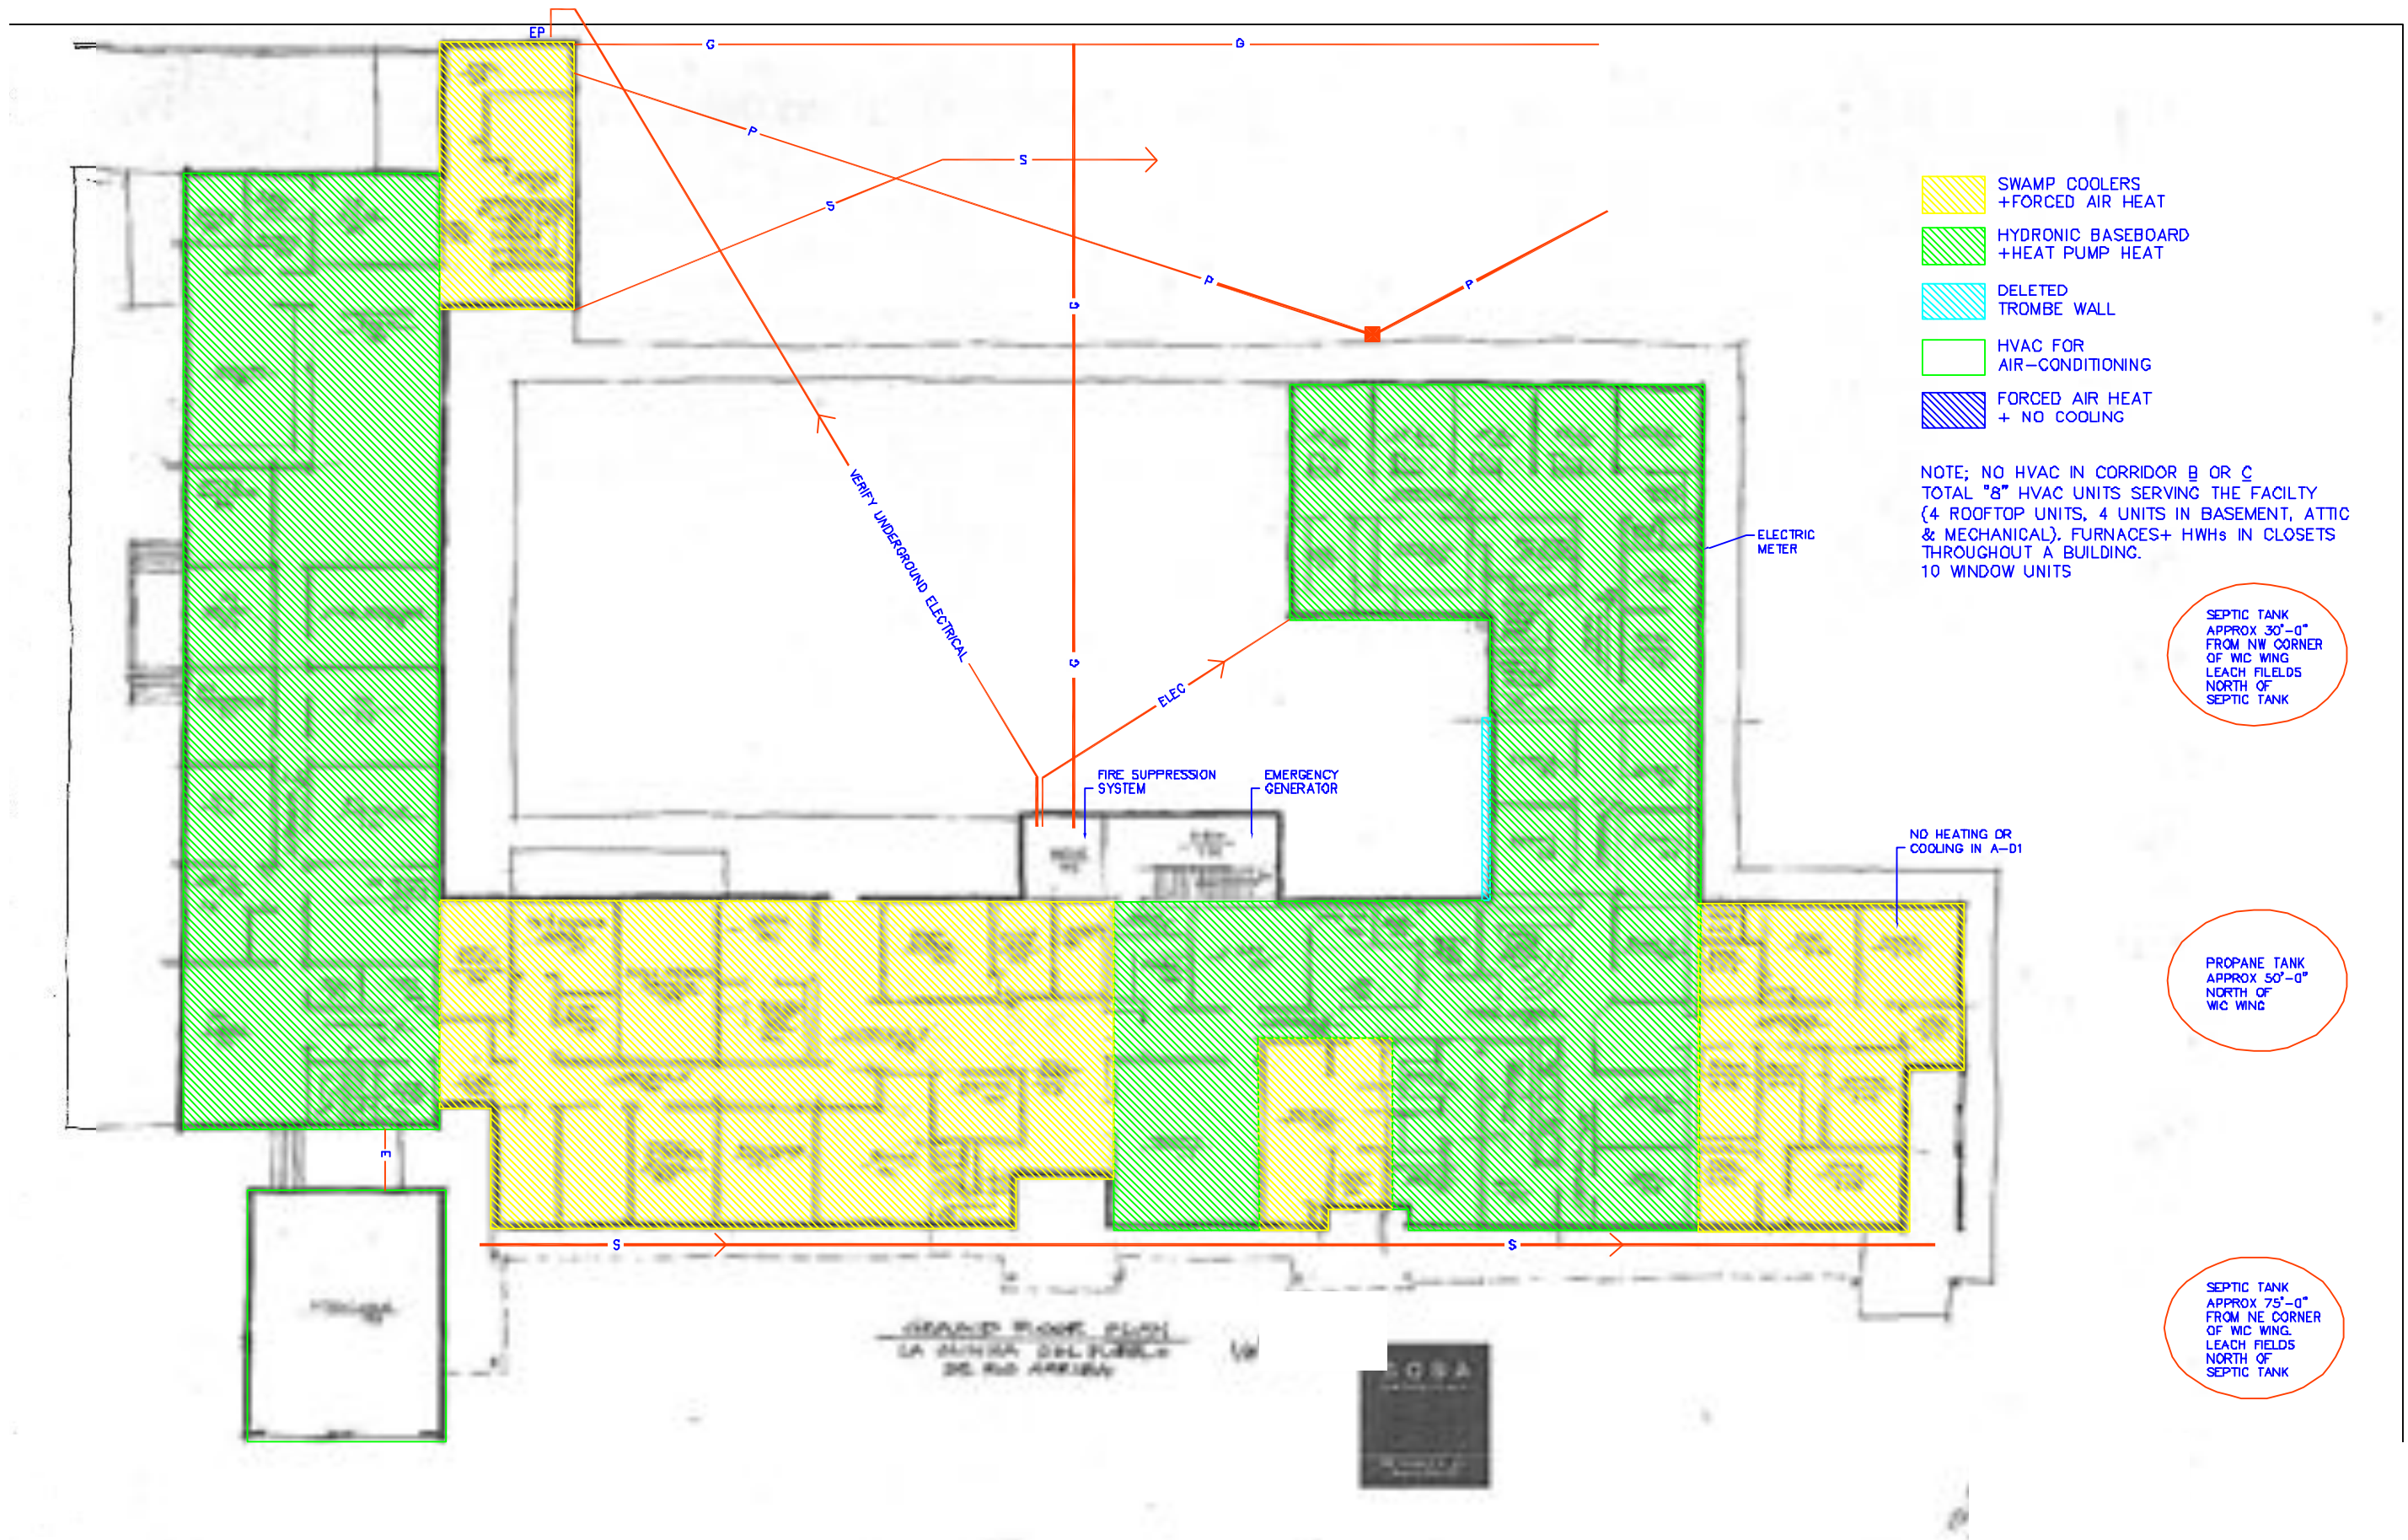
- SWAMP COOLERS +FORCED AIR HEAT
- HYDRONIC BASEBOARD +HEAT PUMP HEAT
- DELETED TROMBE WALL
- HVAC FOR AIR-CONDITIONING
- FORCED AIR HEAT + NO COOLING

NOTE; NO HVAC IN CORRIDOR B OR C
 TOTAL "8" HVAC UNITS SERVING THE FACILITY
 (4 ROOFTOP UNITS, 4 UNITS IN BASEMENT, ATTIC & MECHANICAL). FURNACES+ HWHs IN CLOSETS THROUGHOUT A BUILDING.
 10 WINDOW UNITS
