La Clinica del Pueblo de Rio Arriba

Facility Assessment Study

Phase One

November 9, 2007

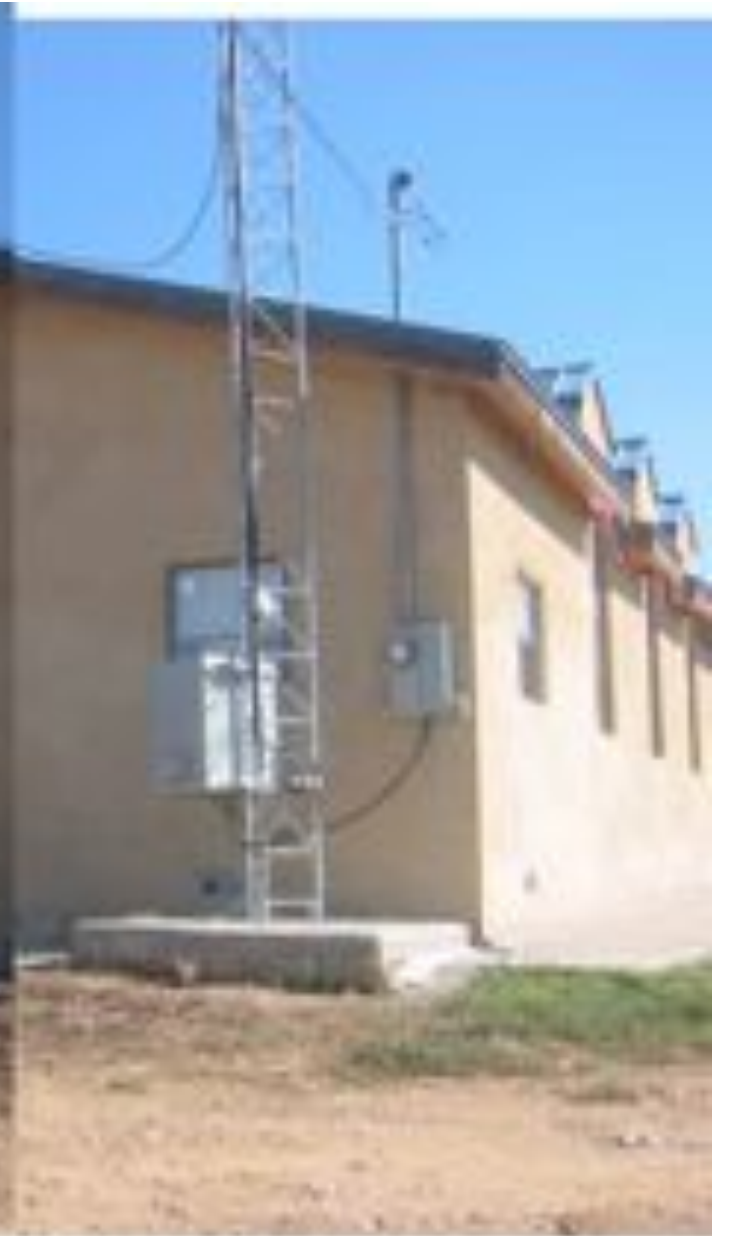
1. At entry and WIC
2. Seeping in from the front walkways and driveways
3. At the building additions – clay soils still under the sidewalk, which absorbs the moisture
4. In the dental – mold problems on the north side of the building
5. Roof overhang is shorter than the sidewalk below – drips on sidewalk, drains into building
6. Dental – has mold in walls and crawl space

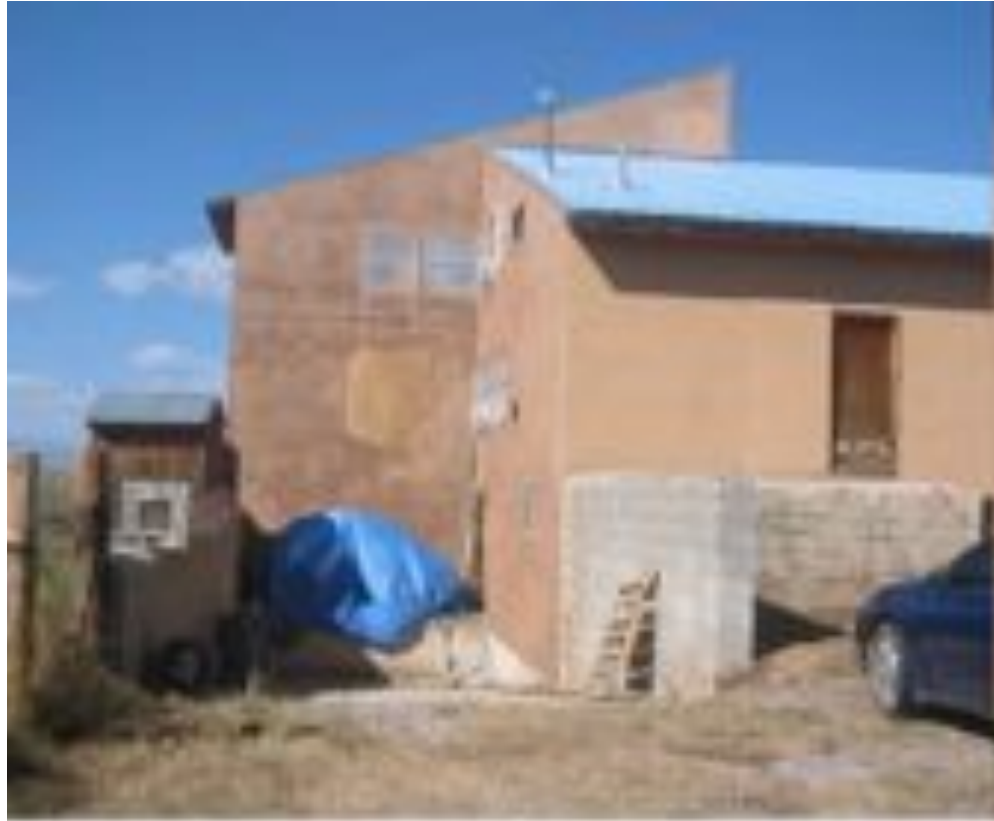
Loading Dock - South Elevation

1. Stairs damaged
2. Sump pump added
3. Every time pond fills, water up to the loading platform
4. Pond 50 feet from wall-seeps in
5. Need to backhoe retention wall and add waterproofing fabric to address the issue

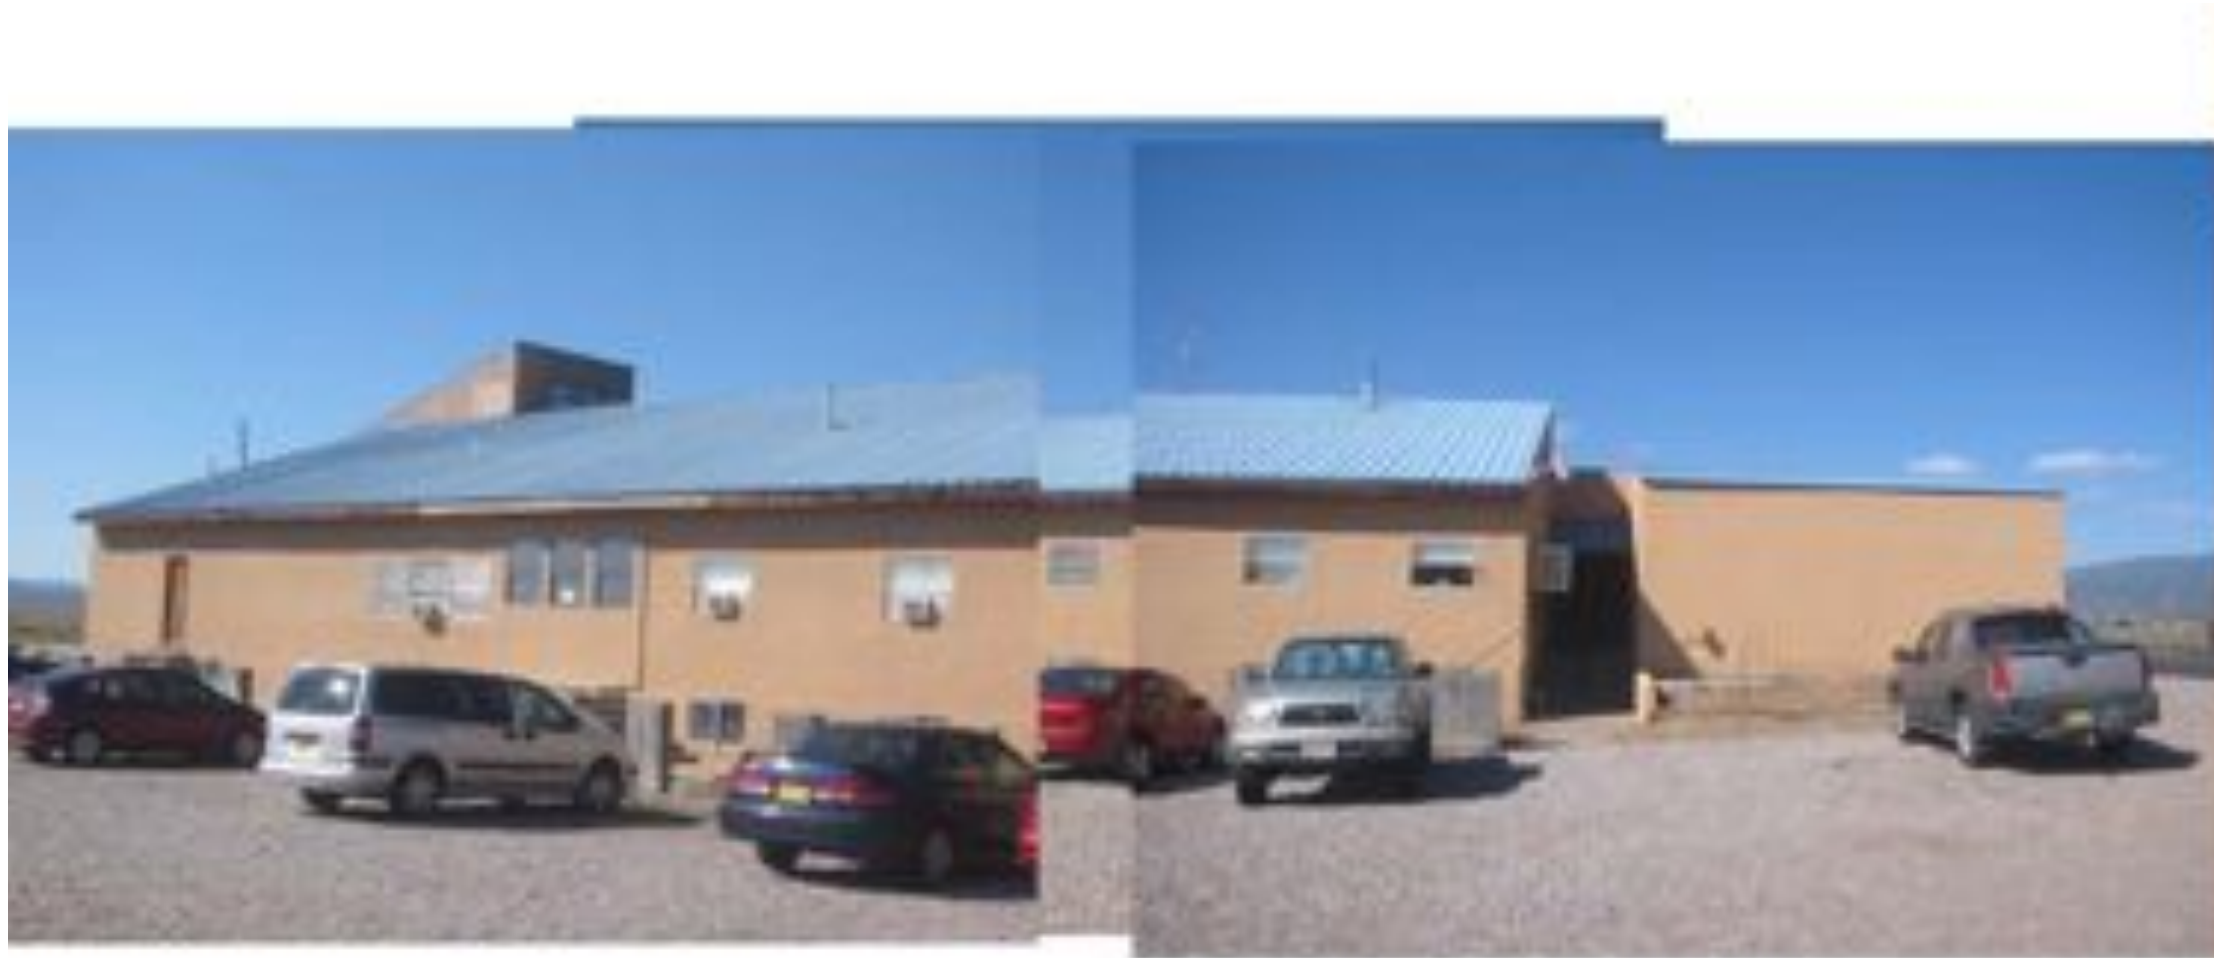
Greenhouse - South Elevation

1. Lobby: Swamp cooler separate, hydronic baseboard – couple of zone valves ducted in attic.
1. Medical-Dental: Hydronic baseboard and heat pump HVAC (dependent on room location)
2. Trombe wall on south side has failed (with plants growing in) and should be removed
3. Too hot, no circulation in one room, due to clerestories in hall and trombe wall
4. West windows are fixed with no shade provided on the west for afternoon sun
5. AC overworks in summer due to overheating of spaces
6. All new wing – WIC – 4 or 5 years ago – swamp cooler
